# FLOOD PLAIN INFORMATION

## ONEIDA CREEK- NEW YORK

PREPARED FOR THE EASTERN OSEWICOMASSON OF FLOOD CONTROL DISTRICTS  
PLANNING BOARD BY THE DEPARTMENT OF THE ARMY  
ENGINEER DISTRICT CORPS OF ENGINEERS, NEW YORK

JULY 1973

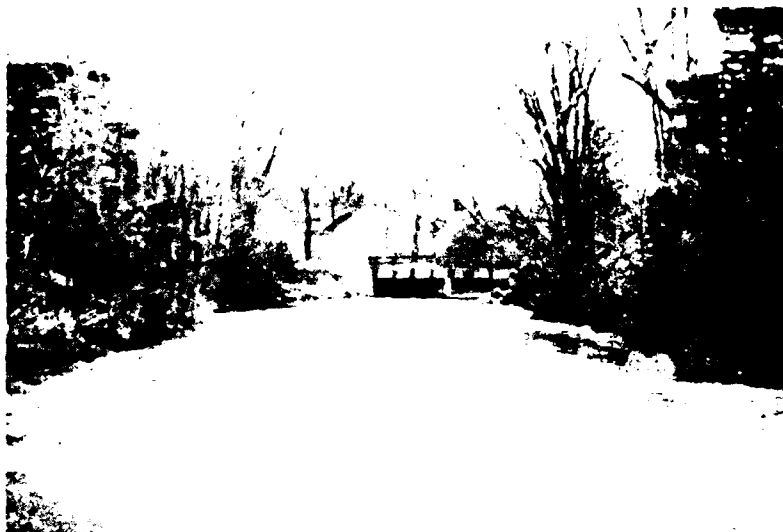
FIGURE 1 - Railroad bridge abutments can cause stream to back up  
(Nov. 9, 1972)

Most of the 21 bridges which span Oneida Creek are obstructive to the flow. They tend to backup flood flows causing inundation of low lying areas upstream. The Erie Canal Crossing and the old New York Central Railroad Bridge near Sconondoa Street are two locations which are especially obstructive to even minor flood flows.

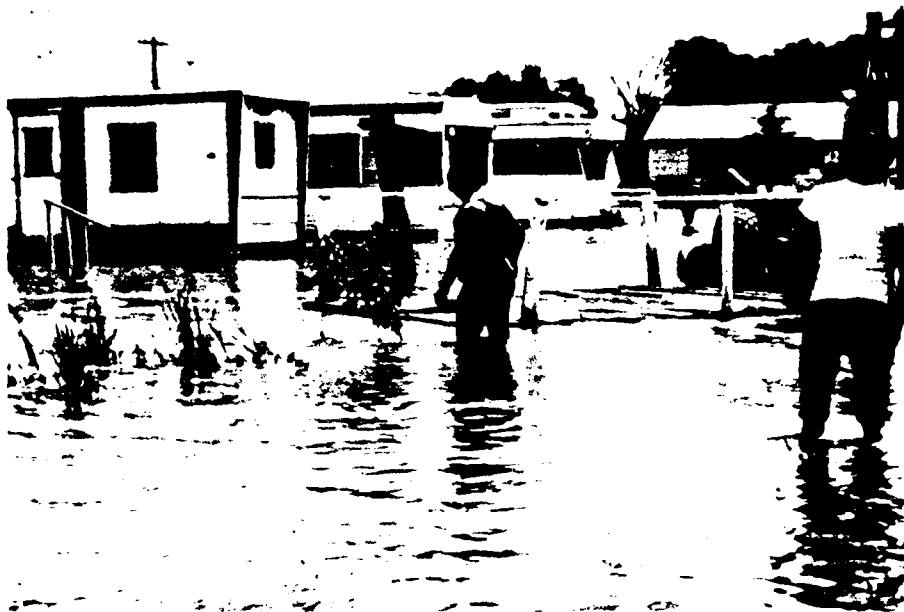
FIGURE 5 - Trailer park adjacent to Oneida Creek was flooded (June 23, 1972)

The Oneida Creek flood plain has been subjected to numerous instances when homes, streets and farm lands have been covered with flood water. Many times this flooding condition does no permanent damage but only creates temporary nuisance conditions. Minor floods such as this often go unrecorded and are accepted as a normal occurrence. Figures 5 to 8 show some of the flooding which has occurred in the past.

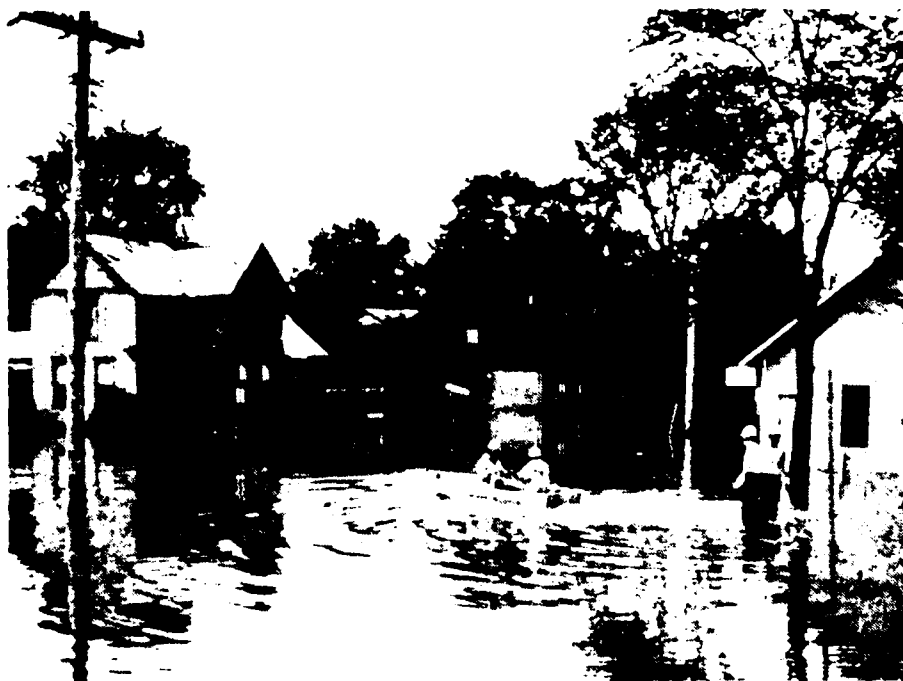
FIGURE 6 - Power crews used boats to shut off electrical power (June 23, 1972)

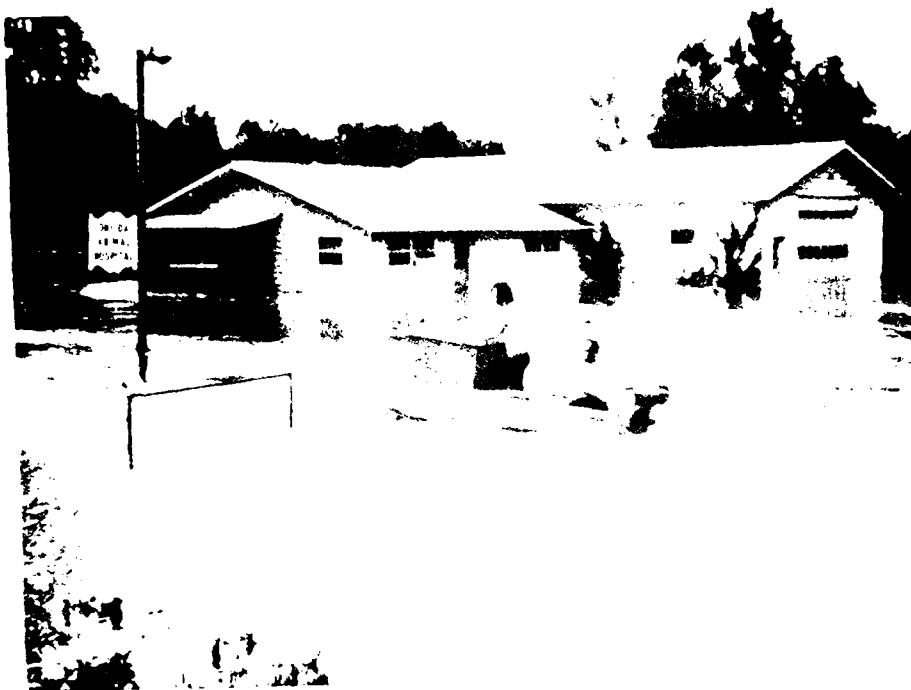
FIGURE 7. Westview Hospital, 1950. (Photograph by the author.)

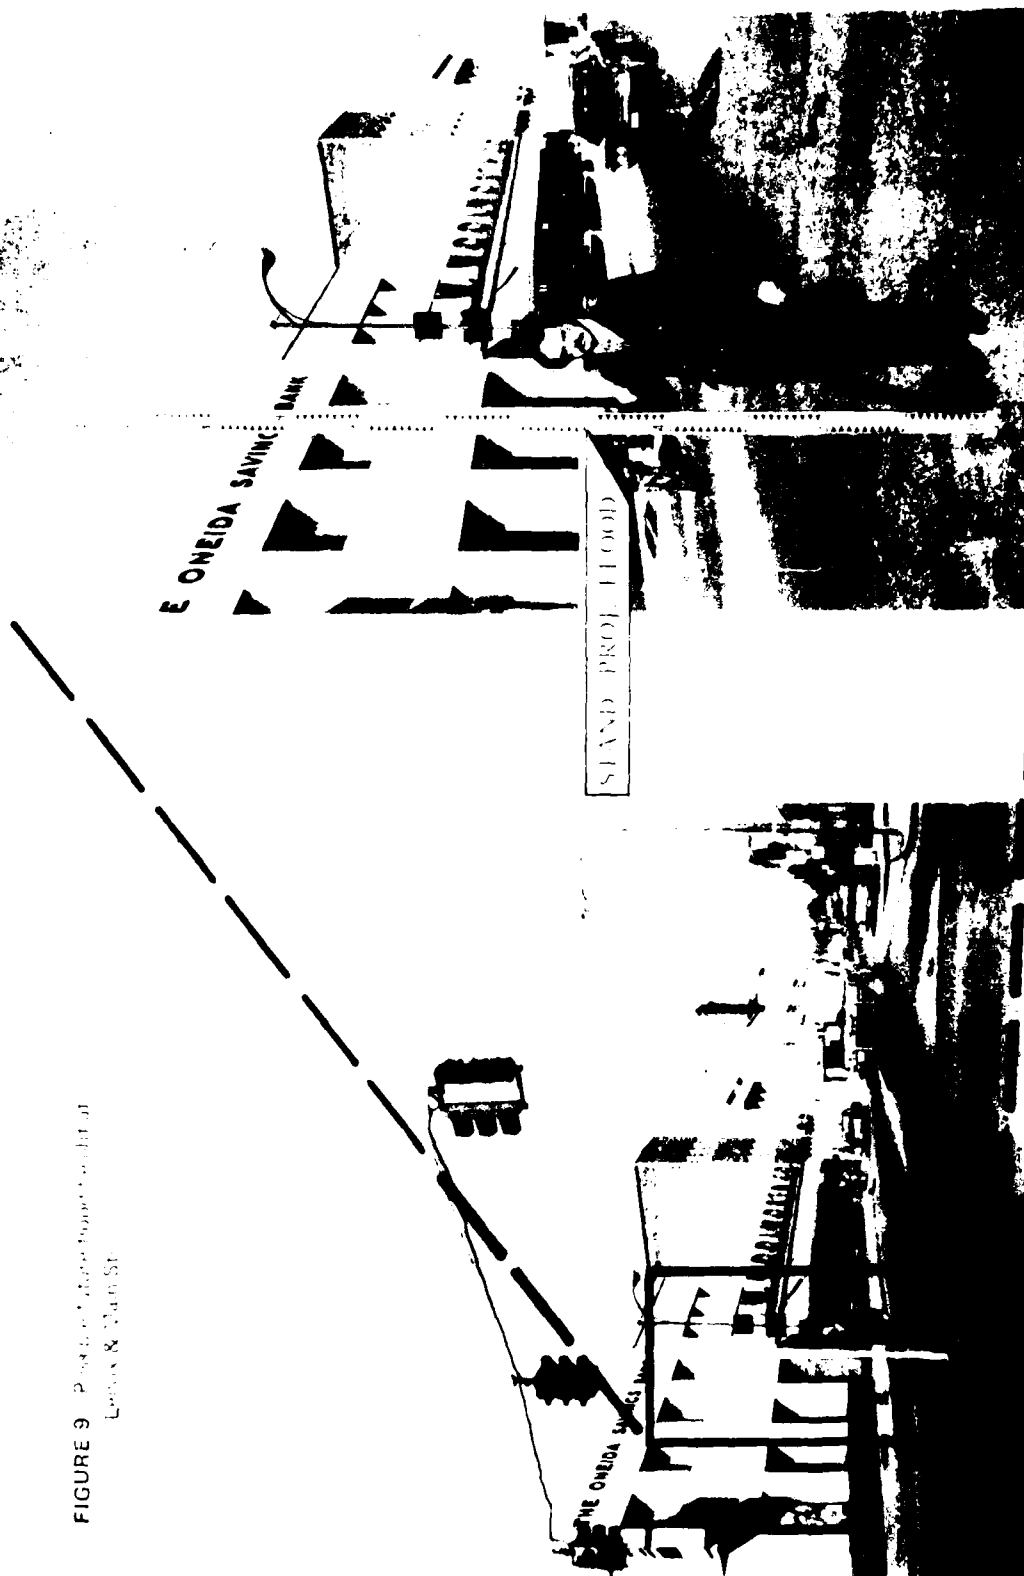
FIGURE 9 - Post-tensioning bridge model at  
Lanes & Van St.

This Study did not include any of the tributaries or land areas adjacent to the tributaries. Without doubt, there are substantial areas of land which will be inundated along the tributaries. Several bridges along the tributaries will be overtopped during the projected flood flows reported herein. Figures 9 to 12 show estimated heights to which the Intermediate Regional and Standard Project Floods will rise in selected locations in Study Area.

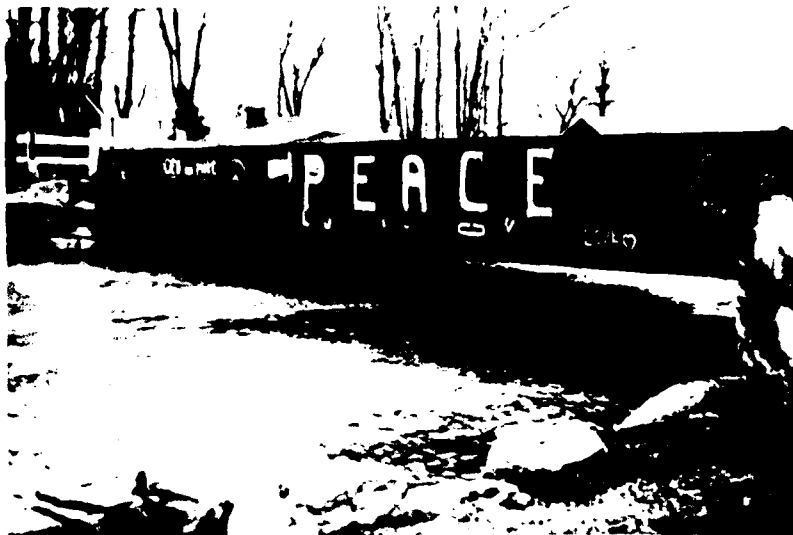
FIGURE 13 - Lake Road Bridge at mouth of Oneida Creek  
(Nov. 9, 1972)

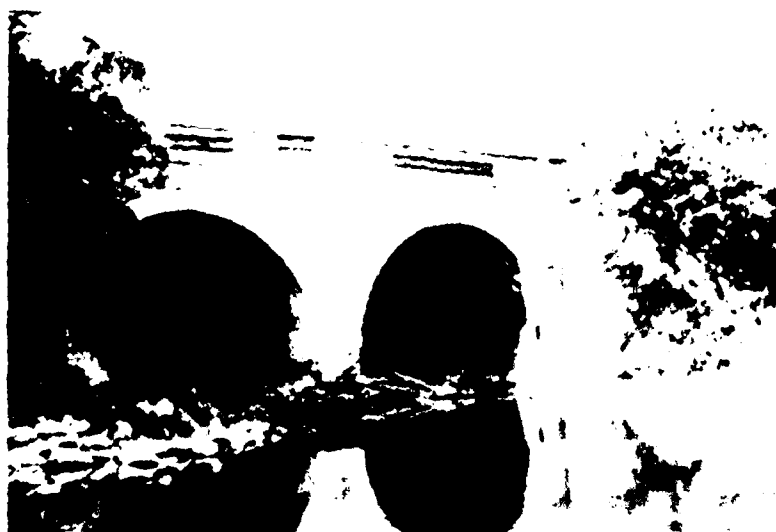
**FIGURE 16** Old New York Central Railroad Bridge. Arched openings would cause SFE flow to inundate much of the City of Oneida. (Sept. 27, 1973)
